Manhole Inspection Summary

Manhole # S29I__043MH

Insp Date: **4/6/09 9:42 AM**

Location Address: **100 Penn**

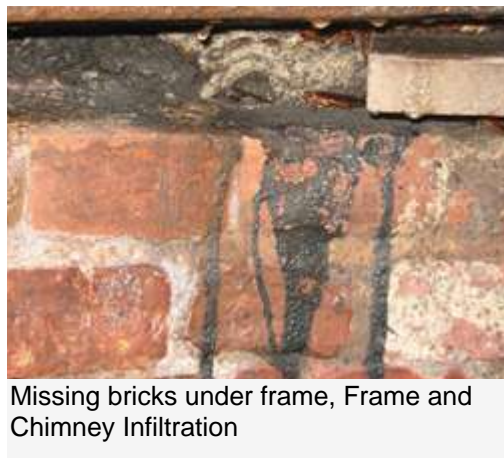
Defect 3

Condition: ☐ Sound ☐ Cracked ☒ **Leaks**

Condition: ☐ Sound ☐ Cracked ☐ Root Intrusion ☒ **Loose Brick** ☐ Deteriorated

Infiltration: ☐ None ☒ **Joint** ☐ Cracks ☐ Mortar ☐ Roots ☐ Wall

Missing bricks under frame, Frame and Chimney Infiltration

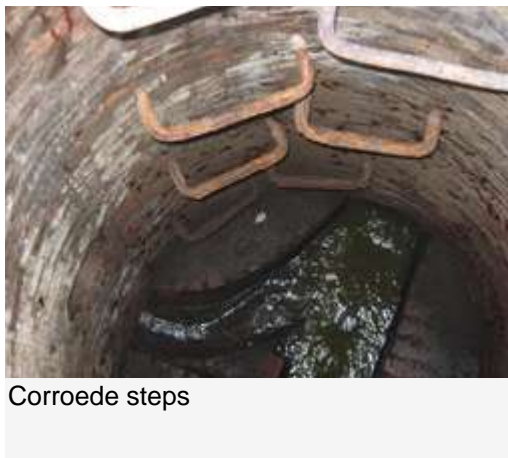
Defect 2

Count: **9** Missing: **0** ☒ **Corroded**

Corroede steps

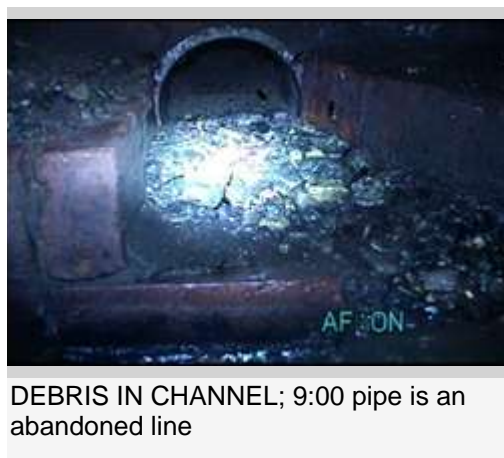
Defect 1

Condition: ☐ Sound ☐ Cracked ☐ Root Intrusion ☐ Deteriorated ☐ Leaks ☒ **Debris**

DEBRIS IN CHANNEL; 9:00 pipe is an abandoned line

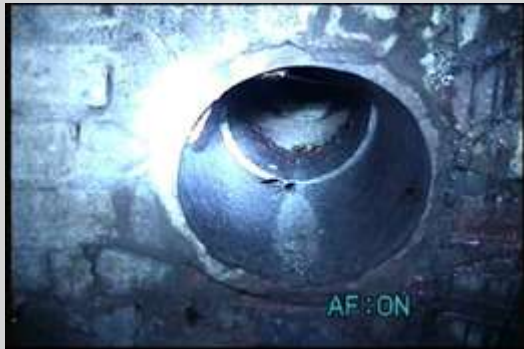
9 O'Clock Inflow

Deposits: ☐ None ☐ Mud ☐ Sludge ☒ **Debris** ☐ Grease

Silt Depth: **0** (in.) Deposits Extent: **Medium**

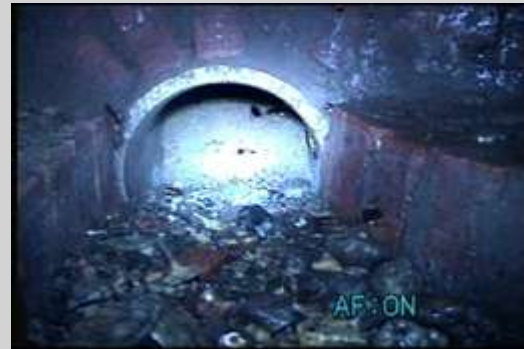
Drop In @ 9 O'Clock

Drop: **Outside** Rod and Bar

Drop Condition: **Clogged**
